Roger J. Wade PE, LS
2172 Havenview Drive
Corydon, IN 47112

August 20, 2025

Re: 6274 Campbellsville Road
Hodgenville, Kentucky

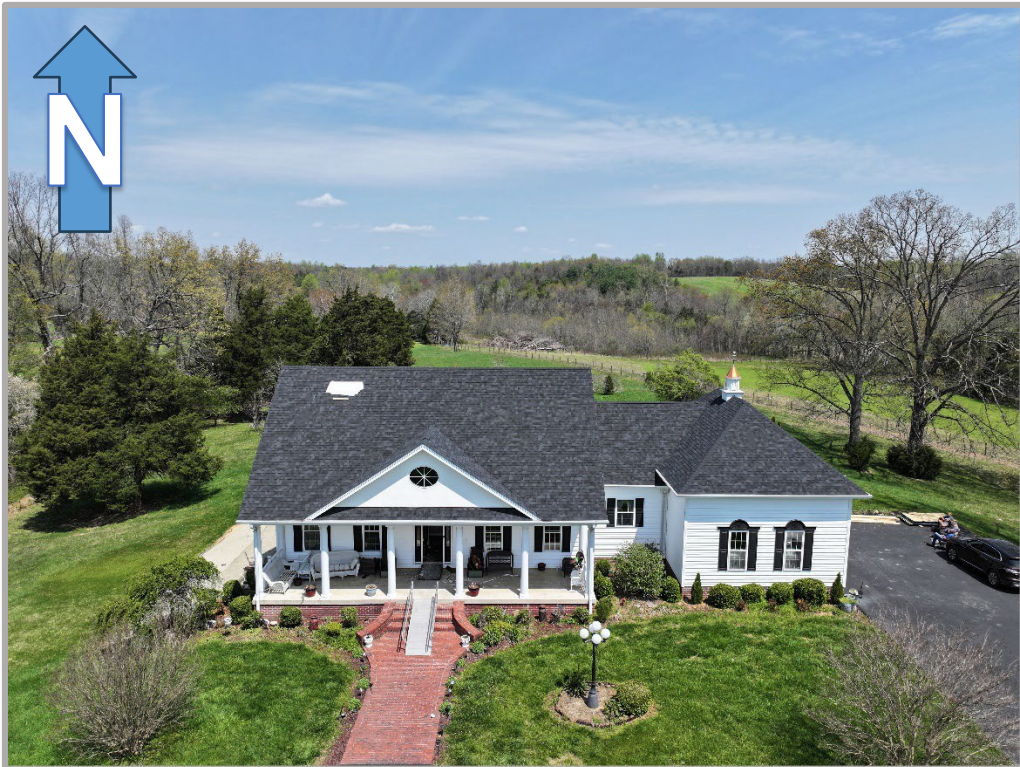
In general, the greatest damage was to the rear of the structure and to the roofing material. While there was significant damage to portions of the load bearing walls, enough of the remaining load bearing walls remained undamaged for the house to remain in a stable structural condition. Without question each of these damaged walls should be replaced with new members. Before replacing damaged floor and roof trusses it will be necessary to place temporary shoring under each damaged area to ensure each does not deflect during reconstruction and cause further damage.

Any member that has experienced loss of section should be replaced with new members in its entirety. Loss of section should be included as any member that can be defined as scaling, flaking or other visible evidence damaged by the fire. Some members that are simply blackened by the smoke damage may be salvaged. It should be noted that the risk of the fire odor may increase as each of the damaged members is salvaged.

Metal hurricane ties and joist hangers should be replaced on all fire damaged members. Some of these metal elements may need to be replaced even if the wood members are salvaged. The extreme heat of the fire may significantly reduce the strength of each of these elements.
